## LAB ANALYSIS REPORT

<b>Company:</b> RVI 304 Industrial Drive Redwood Falls, MN 56283	<b>Date:</b> April 20, 2010
<b>Submitted by:</b> Doug Houle <b>Ph.</b> 507-644-3227	<b>Report No.:</b> 10-0238
	<b>P. O. No.:</b> 012622-001
	<b>Page 1 of 5</b>

Received two (Q7, Q21/TO-247AD package) for analysis.

Package markings: 20N60CFD GHD840

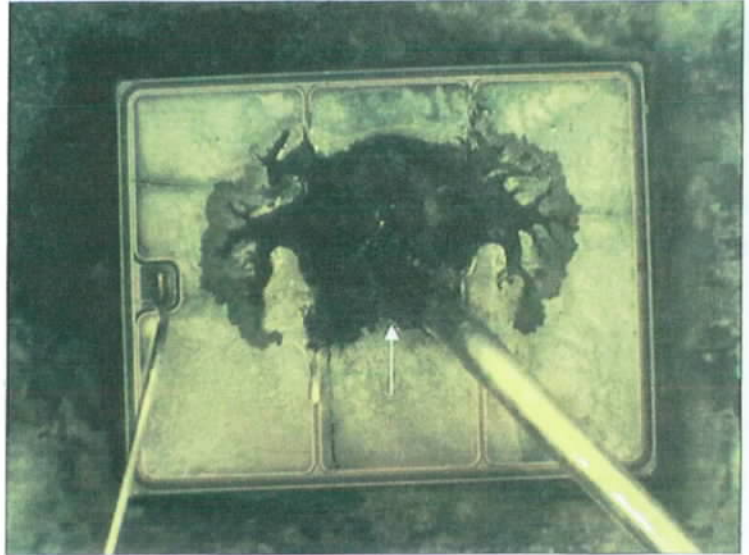
**Figure 3.**

Decap revealed severe EOS/localized heat damage beneath the source wire bond on the die surface.

**Optical view of the dip surface of Q7, illustrating the EOS/localized heat damage at the source wirebond area (arrow).**

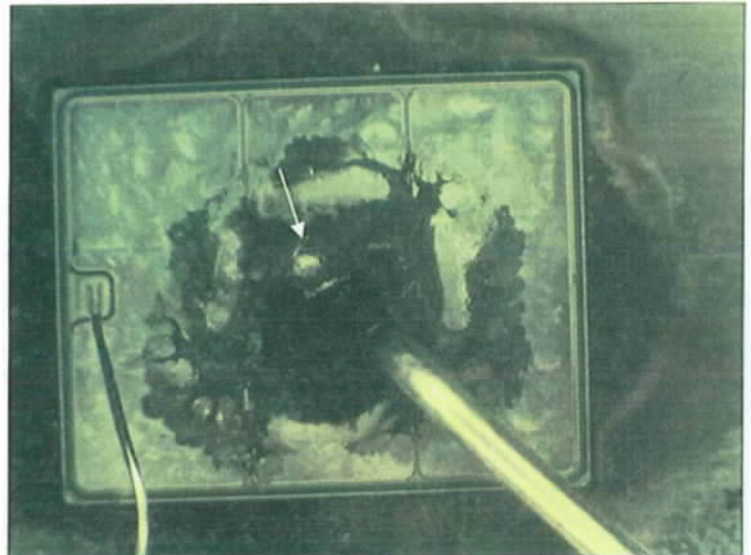
**Figure 4.**

**View of the die surface of Q21, illustrating the EOS/localized heat damage (arrow).**

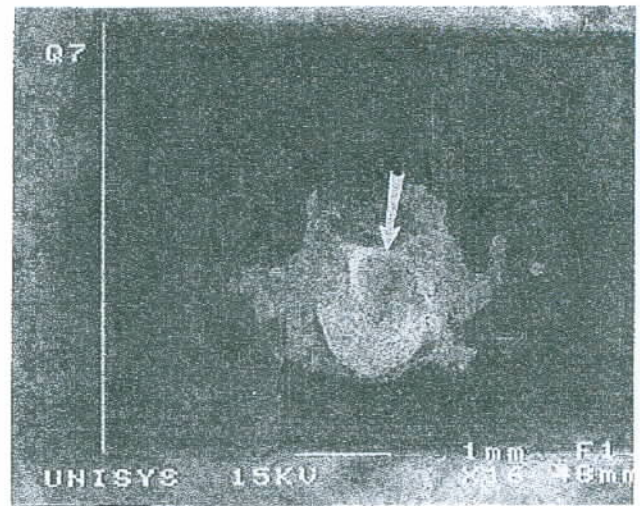
**Figure 5.**  
16X

**SEM view of the delayered die surface of Q7, illustrating the localized heat damaged area (arrow).**

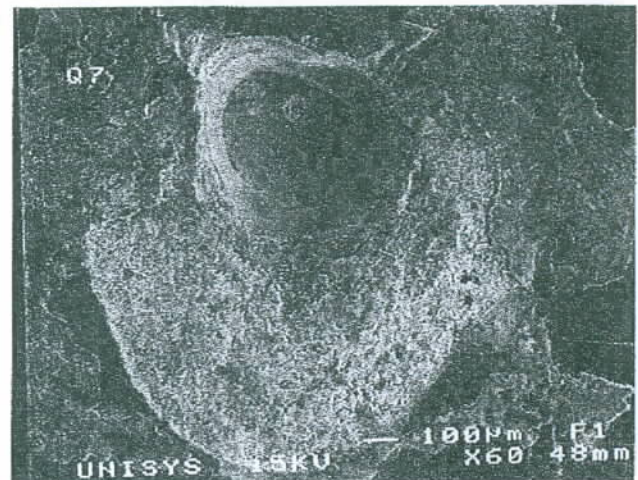
**Figure 6.**  
60X

Both MOSFETS were shorted due to EOS/localized heat damage on the die surface, originating beneath the source wire bond.

**Closer SEM view of the localized heat damaged area of Q7. Intense heating caused melting of the silicon bulk.**

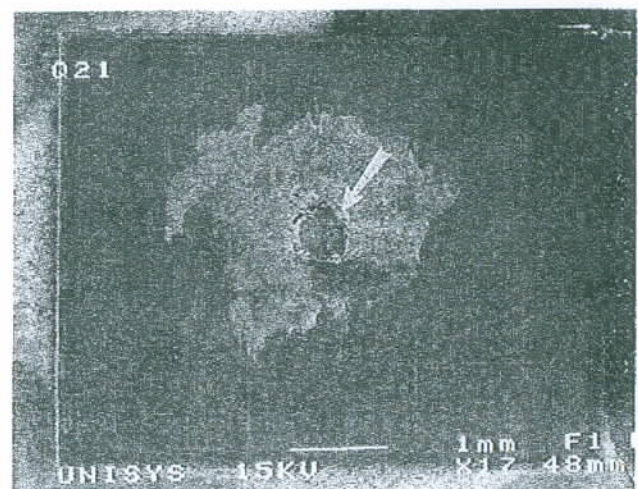
**Figure 7.**  
17X

**SEM view of Q21, illustrating the hole in the silicon bulk (arrow) due to intense heating.**

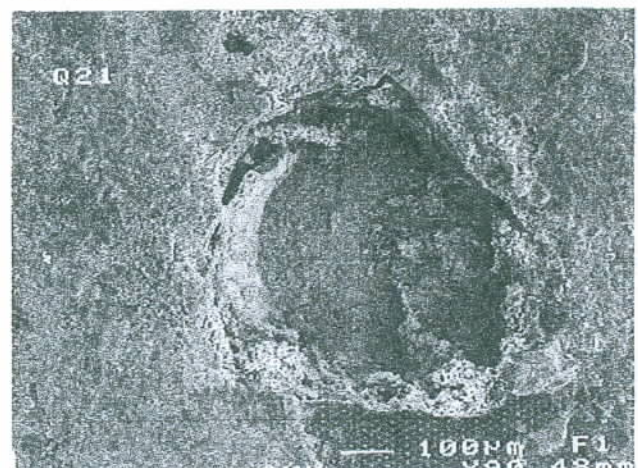
**Figure 8.**  
90X

**Closer SEM view of the localized heat damaged area of Q21.**
