CUSTOMER NAME	:	5)	RMA#	:	
CUSTOMER P/N	:		RMATS#	:	
MANUFACTURE NAME	:	Artesyn Technologies	CUST. REF#	:	LSU0020877
MANUFACTURE P/N	:	7000977-Y000	RVI WORK ORDER #	:	378411
FAILURE LOCATION	:		DATE RECEIVED	:	08-27-07

CUSTOMER'S FAILURE DESCRIPTION Breaker AC1 Tripped

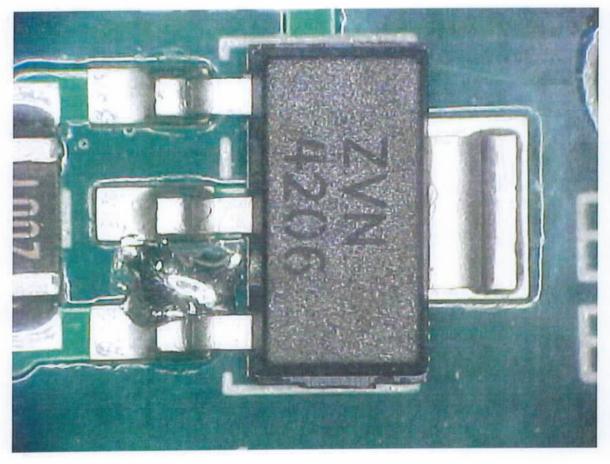
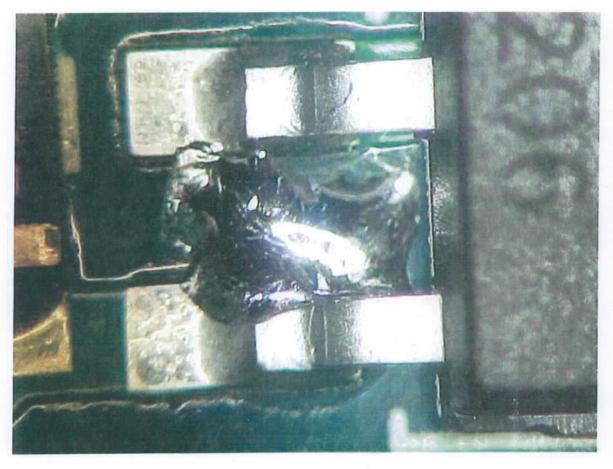
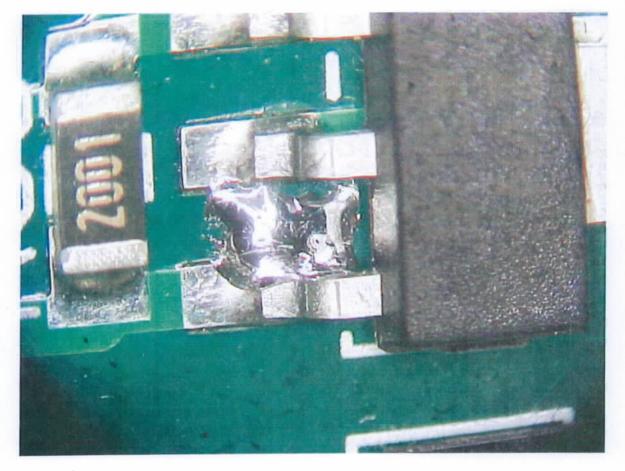
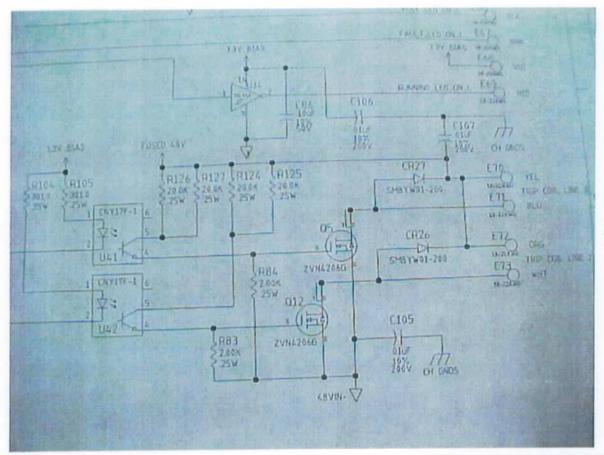
ATTACHMENT	
4 Photos

RVI VERIFICATION		March State of the Party of the State of the	
	Failure symptom	Vis	ual Inspection
	AC1 Breaker Tripped	Solder spla	ash across legs of Q12
FAILURE ANALYSIS		Note that the second second	
Investigation & Analysis			
splash provided "48VIN trip when the "Fused 48 Component : Solde	n Q12. The solder splash was acro " or return potential to be applied V" was present. er splash on Q12 causing it to trigge	to the trip coil connection, caus	sing the breaker to
Measurement Component :			
PROBABLE CAUSE	A STATE OF THE PARTY OF THE PAR		
Workmanship issue from	n the factory.		
Classification of Failure :	Design Problem :	Workmanship	: X
	Component Problem :	Handling Problem	;
	Process Problem :	Others	:
